Magnet Incident

Background

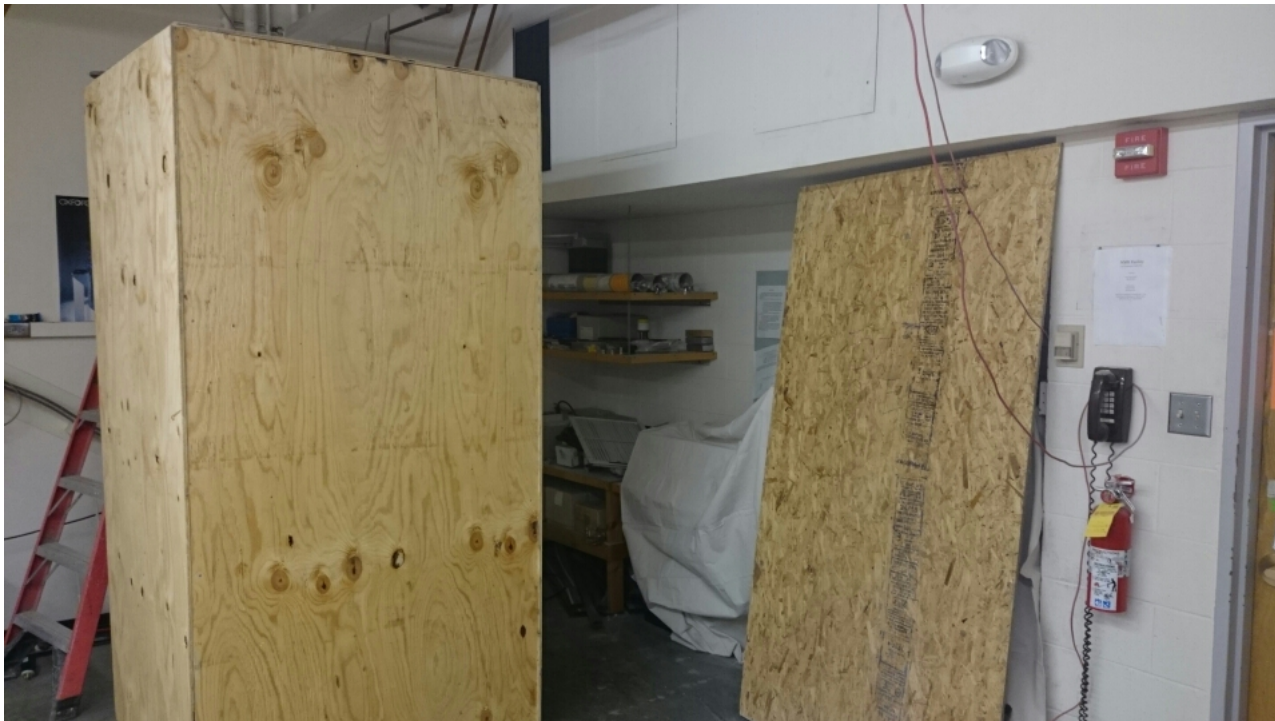
All electronic equipment was turned off, and easily removable equipment was removed. Consoles were covered with tarps. The magnets remained energized, and boxes were built around them, covering 3 sides and above. One side was left open to allow access for cryogen fills.

This shows the one of the boxes.

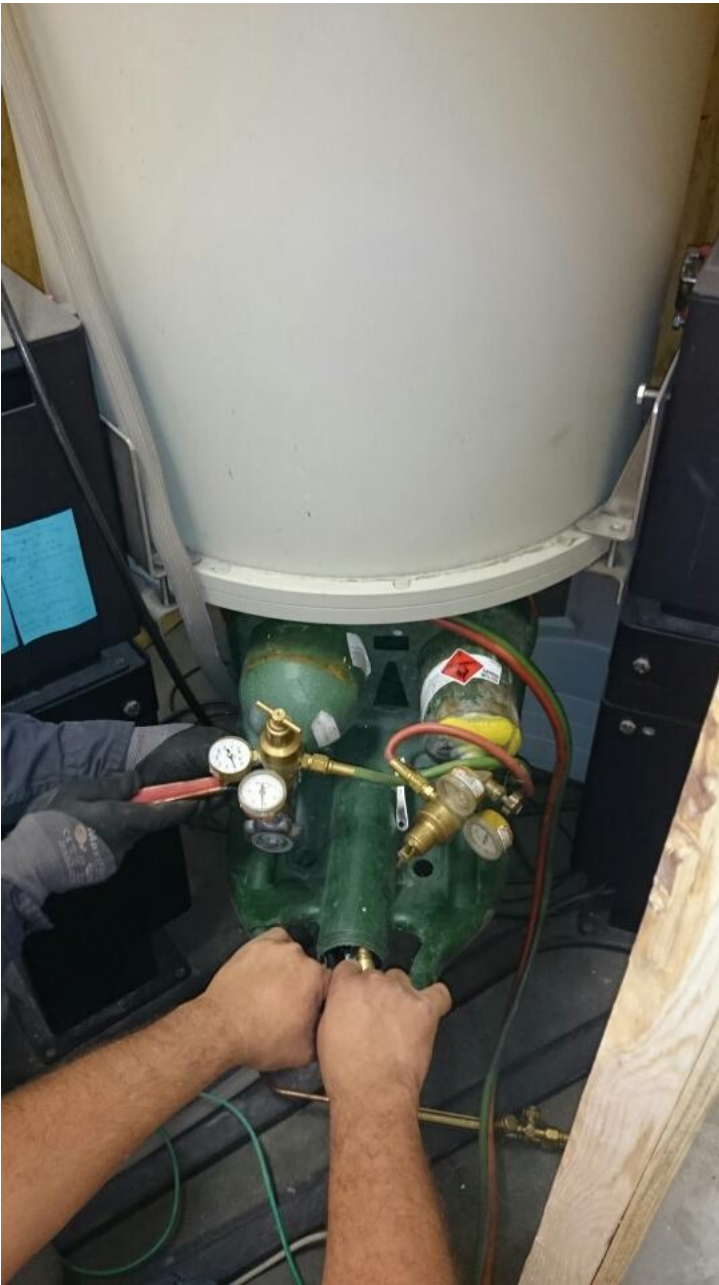
A worker on the fluid line walked around behind the 500 carrying a welding pack with nozzle and gas tanks. He held the unit on the side of his body away from the magnet and walked as far as possible (about 3 feet) away. The field grabbed the bottles, pulled them out of his hand, and under the magnet, striking the shim plate. The force on the bottles twisted his arm behind him, and then pulled the bottles out of his hand. No one was injured.

Several workers tried to remove the bottles, but they wouldn't budge. Then, the magnet started venting, and the bottles fell to the floor. The room was evacuated until the magnet stopped venting.

This shows the tanks under the magnet.

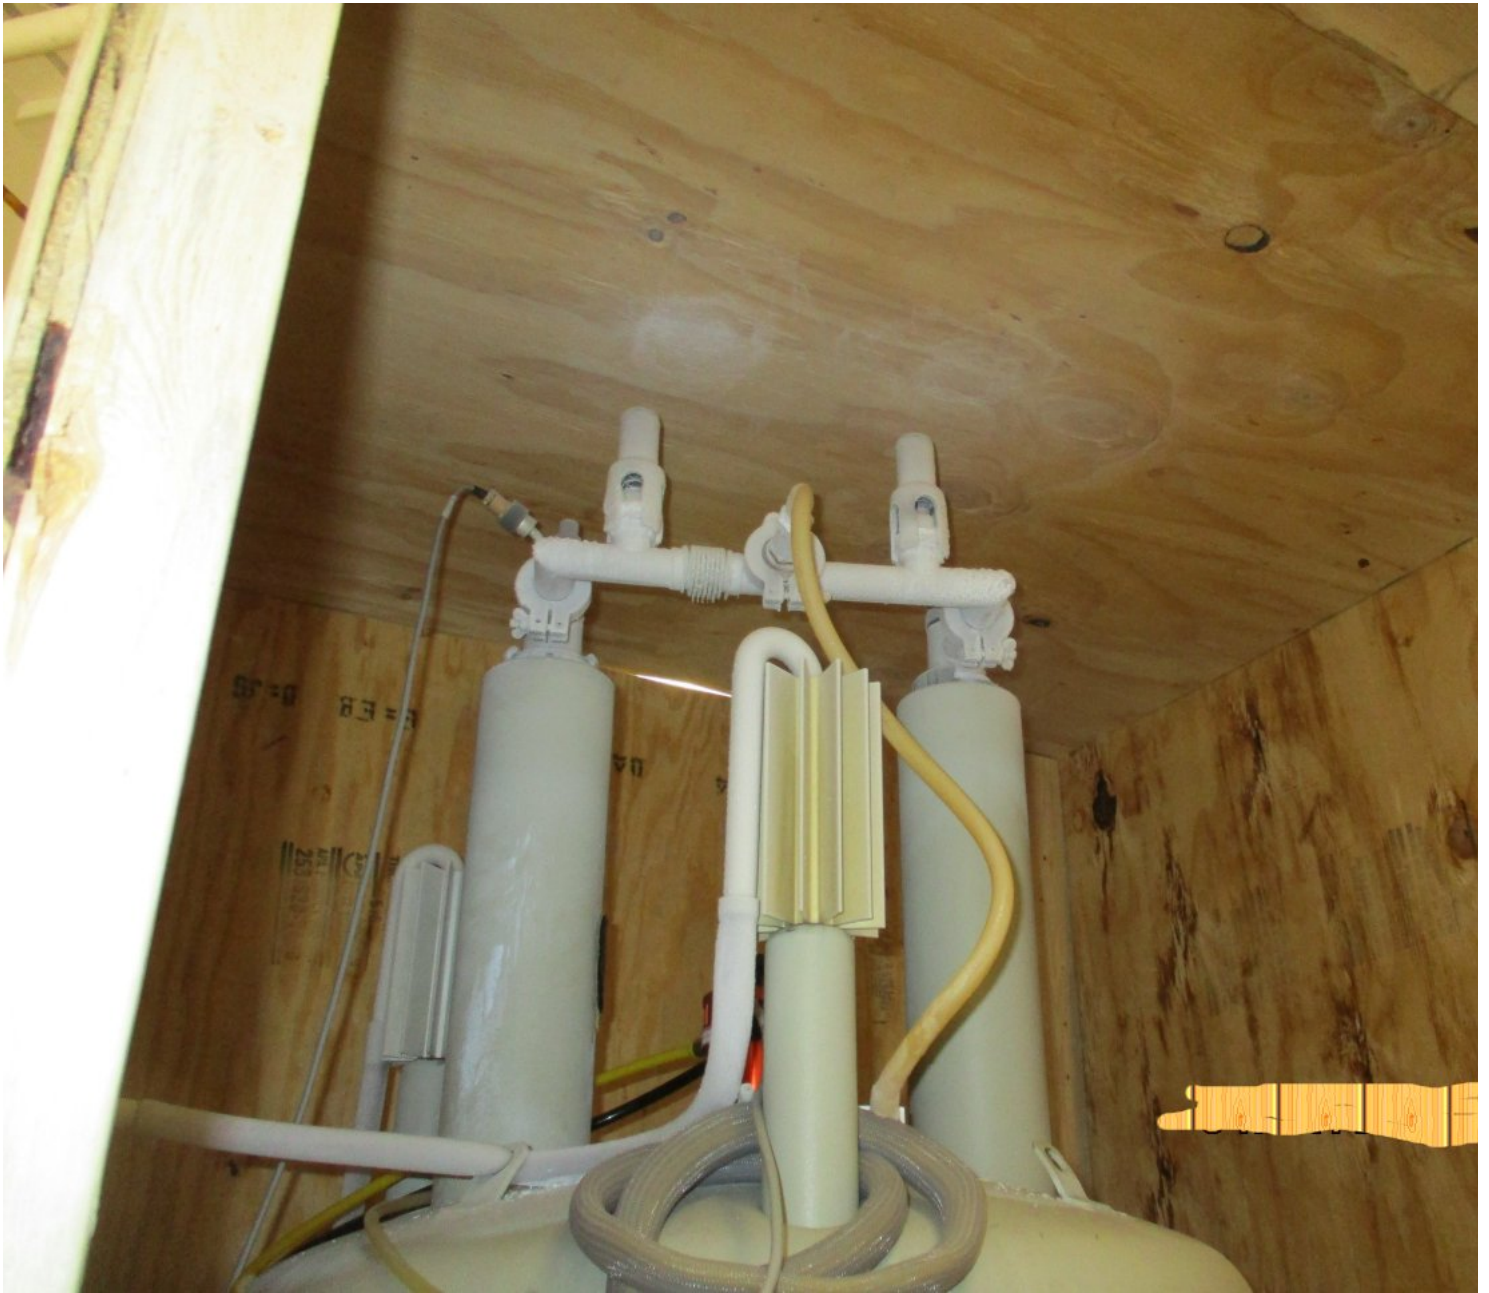
This shows the magnet venting (you can see the top of the box as well.)

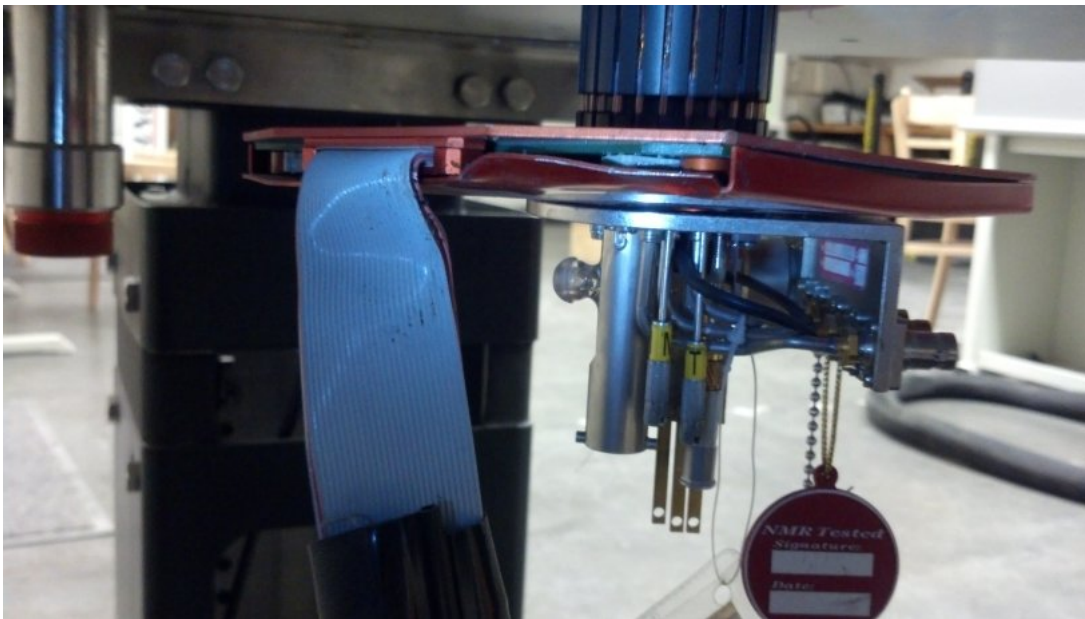
The bottles hit the shim plate, and thus did not shear off the probe that was in the magnet.

This tries to show the shim damage- the upper left side is bent.

The extent of damage to the probe is unknown at this point- it hasn't been removed from the magnet because it won't move. At some point, we will get aggressive and remove it. The shims are a total loss.

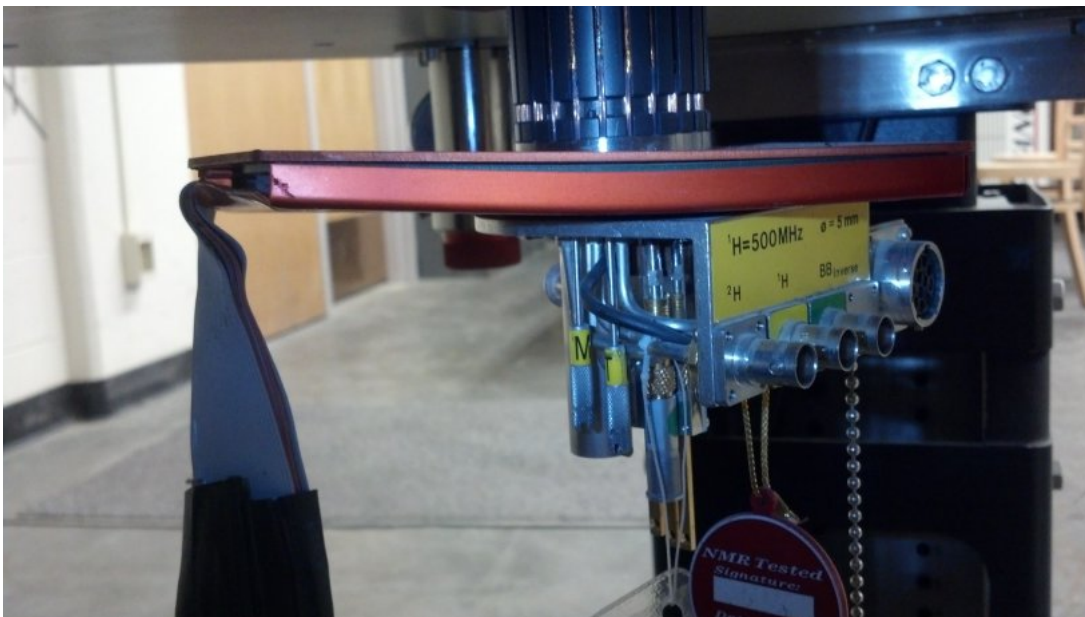
A second picture.
